# Experiences of an intervening surveyor and demands on a well functioning salvage system

# TMV „Waldhof“

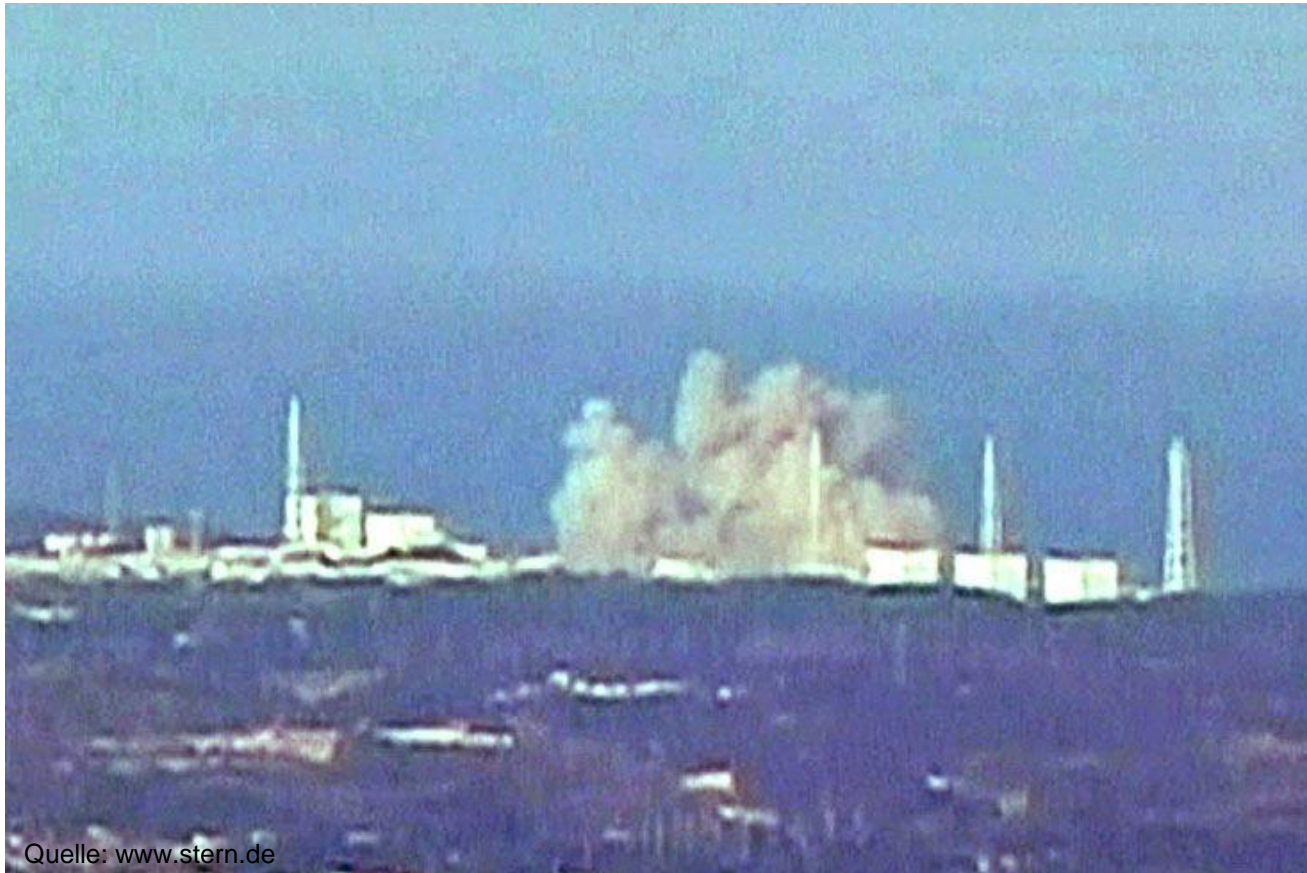
# Hydrogen explosion

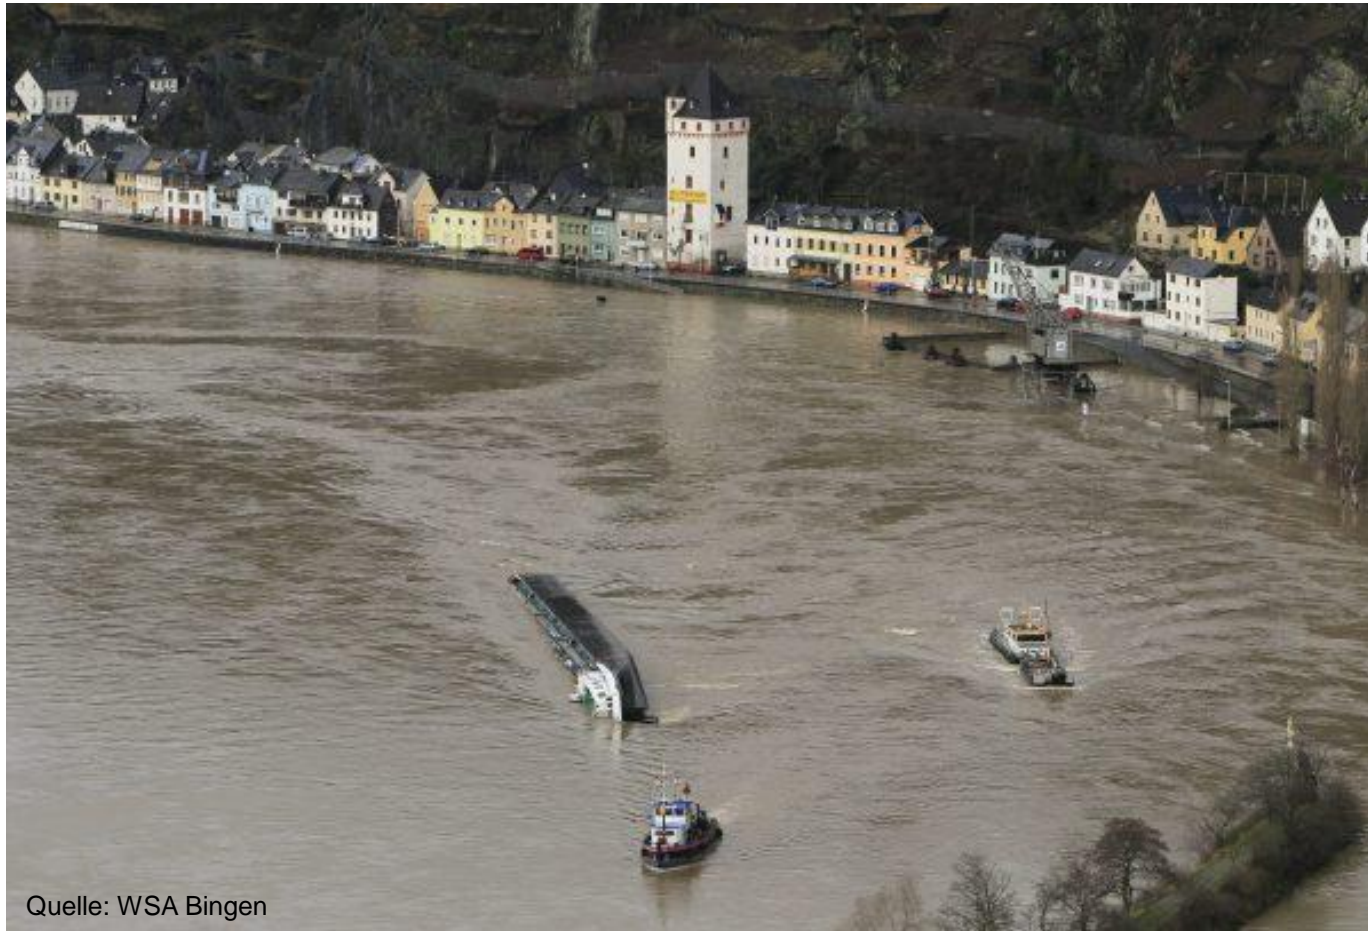
# The situation of the vessel

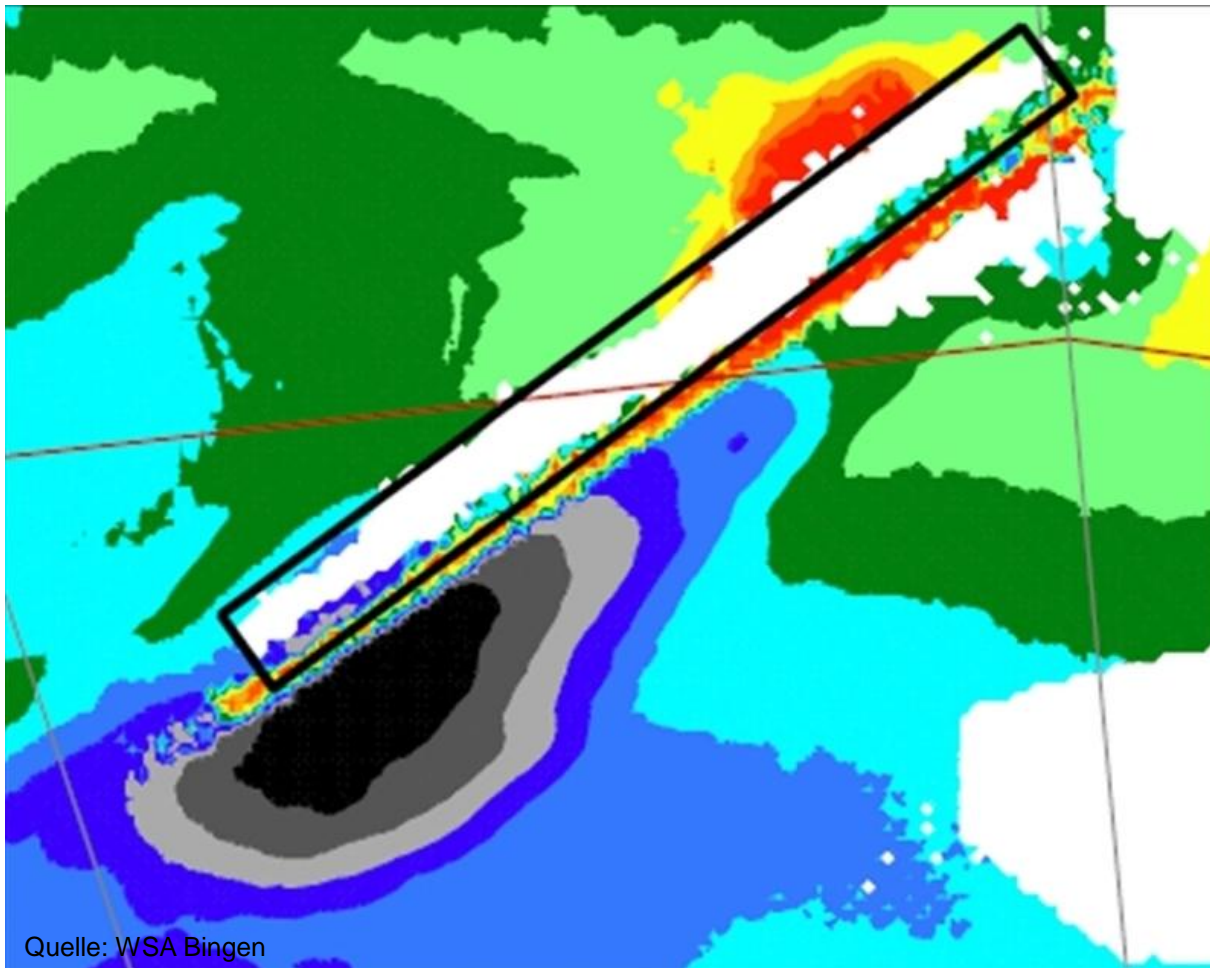
# The „black hole“
